Launch March 2, 2019
Great Meadow
Motor Autopsy

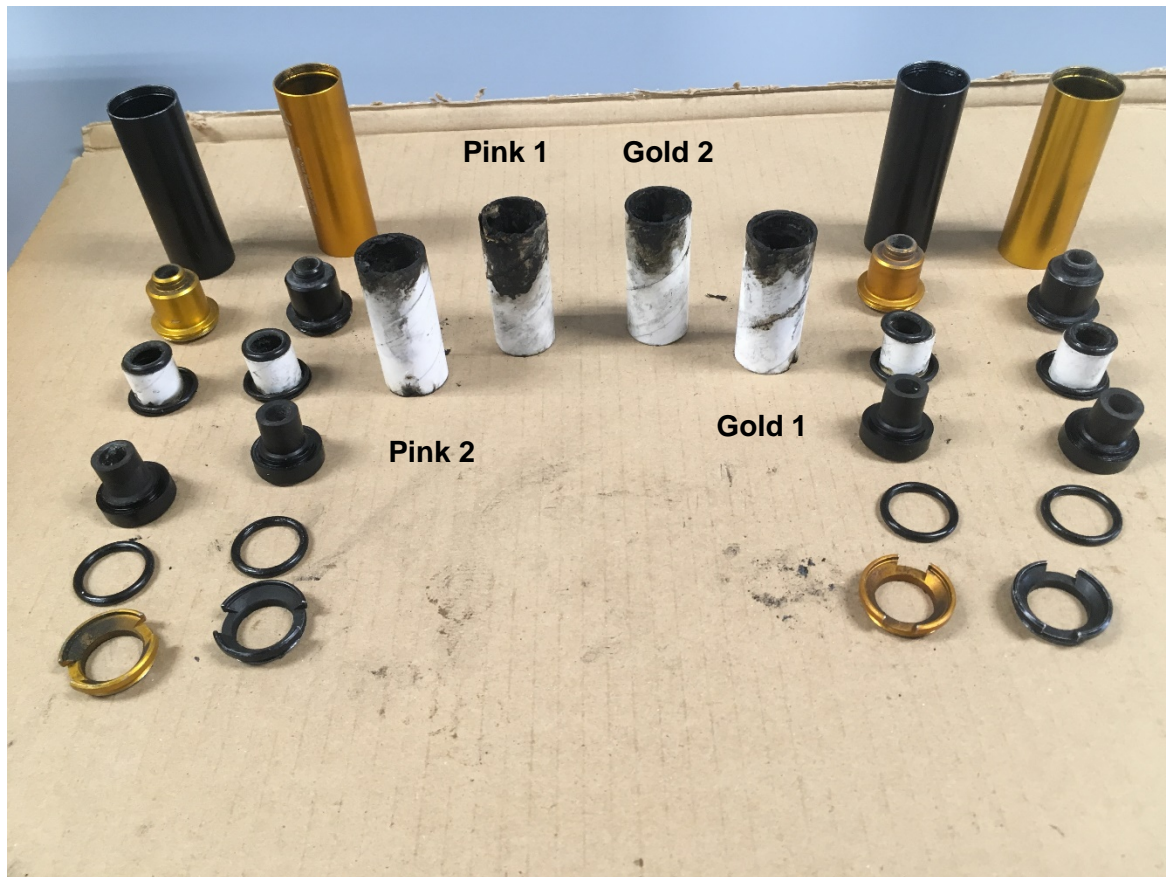
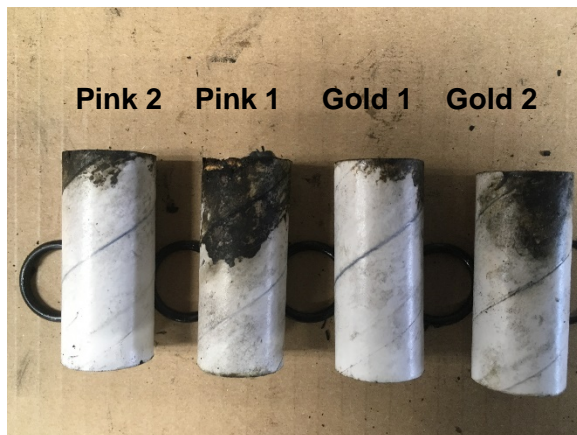
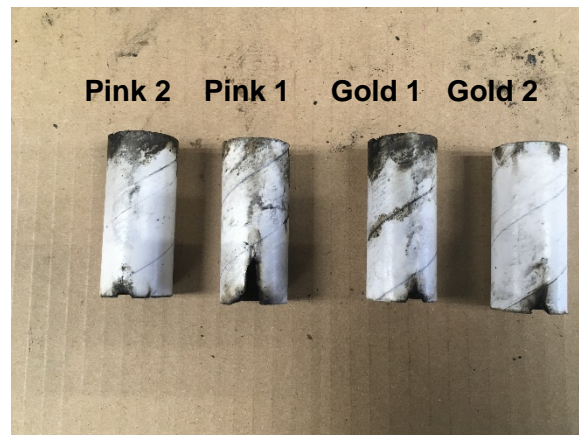
Here are the motors from the two Pin k and God rocket flights.

Notice the burn marks on the Pink 1 motor insulator. It is likely that the igniter was not fully inserted, which caused fuel to burn but not create thrust.

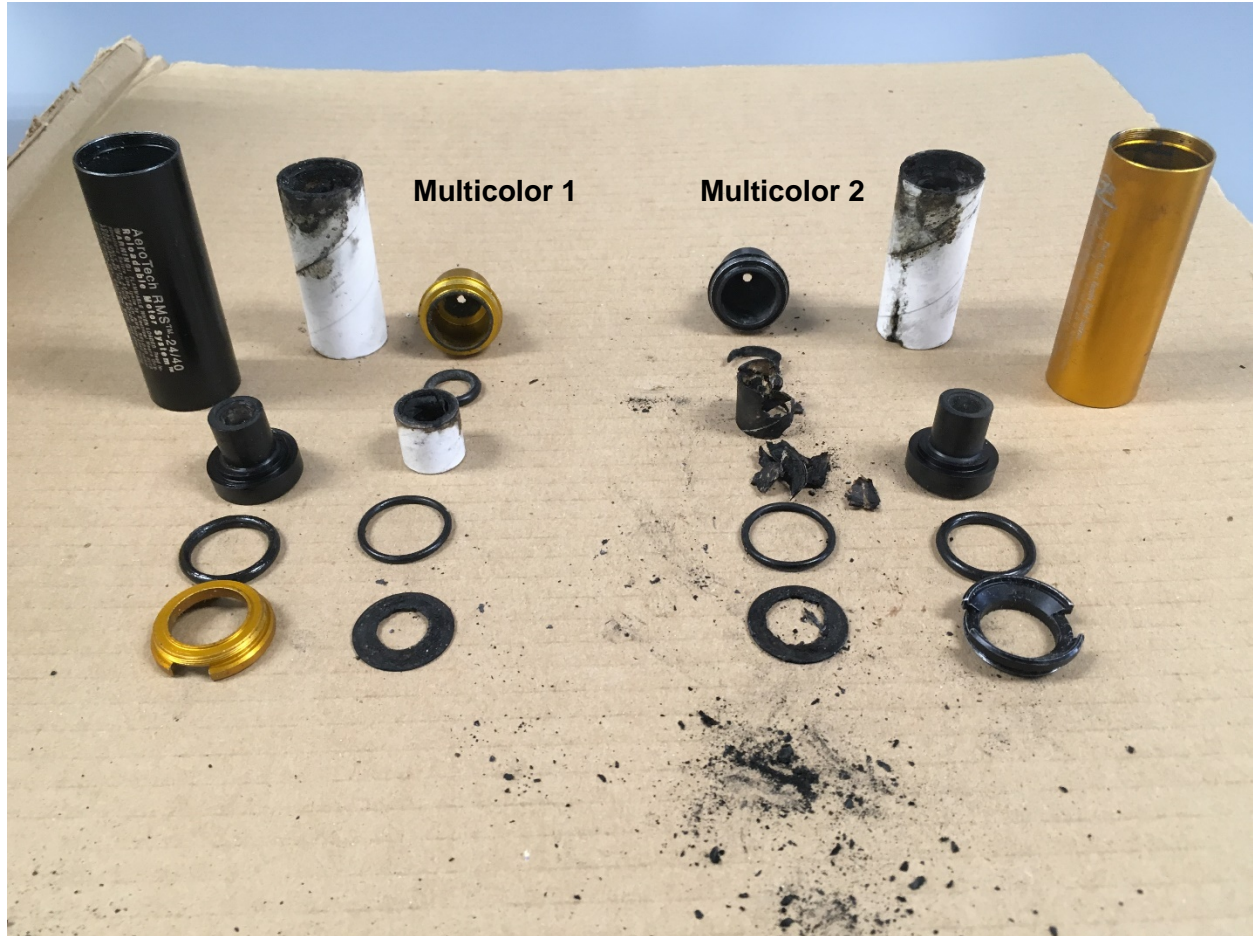
Here are the two motors from the Multicolor rocket flights.

Notice the destroyed delay element in the second flight. After reviewing and disassembling the other two motors from the same lot/pack, it was determined that they were assembled incorrectly.
